Manhole Inspection Summary

Manhole # S53AA_007MH

Insp Date: **7/17/08 11:32 AM**

Location Address: **rear 3111 mcelderry st**

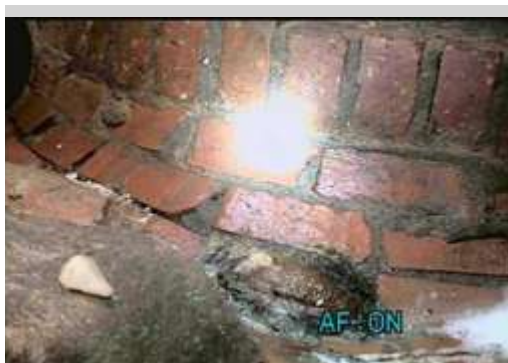
misc

channel debris

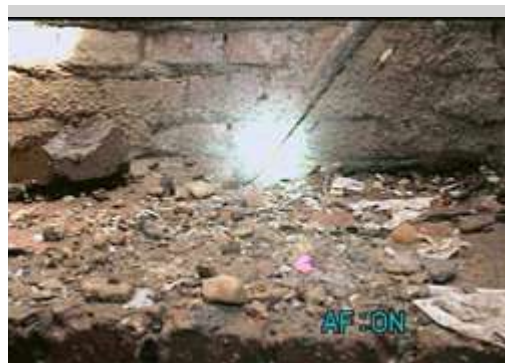
misc

bench debris

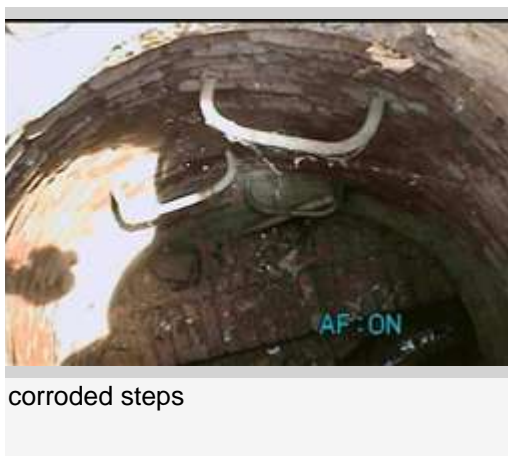
Defect 2

Steps Count: **3** Missing: **0** ☒ **Corroded**

corroded steps

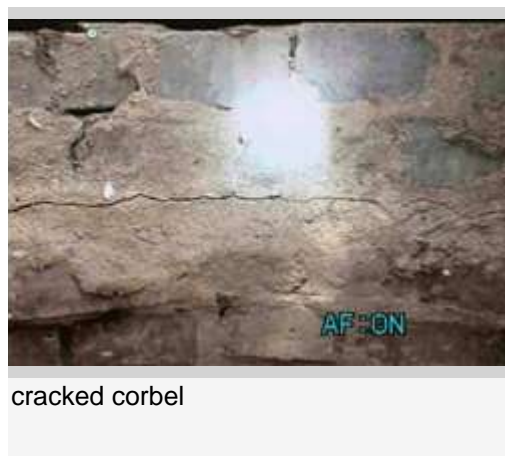
Defect 1

Condition: ☐ Sound ☒ **Cracked** ☐ Root Intrusion ☐ Loose Brick ☐ Deteriorated

cracked corbel

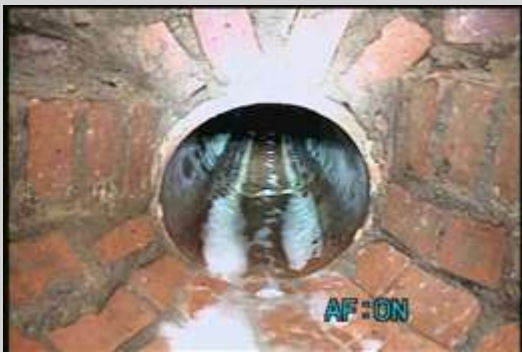
12 O'Clock Outflow

8 in. Circular Gravity Sewer
Pipe Out @ 12 O'Clock

Invert Depth: 7.68 (ft.) Flow Characteristics: **Fast**

Infiltration: **None** Pipe Seal Cond: **Unknown**

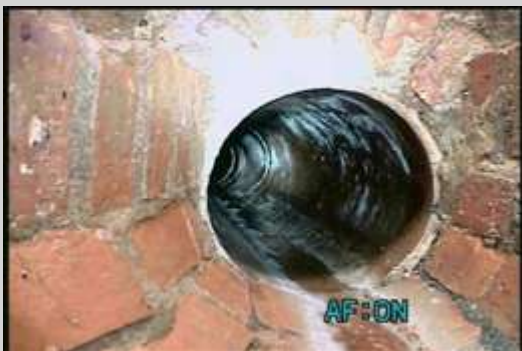
3 O'Clock Inflow

8 in. Circular Gravity Sewer
Pipe In @ 3 O'Clock

Invert Depth: 7.55 (ft.) Flow Characteristics: **None**

Infiltration: **None** Pipe Seal Cond: **Unknown**

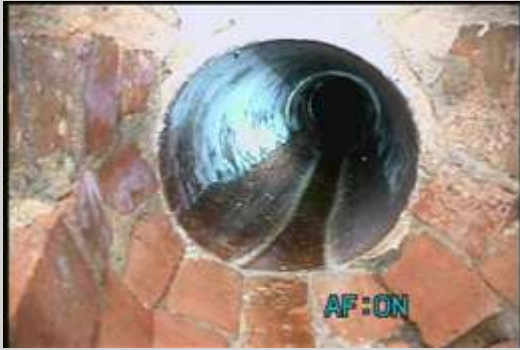
9 O'Clock Inflow

8 in. Circular Gravity Sewer
Pipe In @ 9 O'Clock

Invert Depth: **7.34** (ft.) Flow Characteristics: **Slow**

Infiltration: **None** Pipe Seal Cond: **Unknown**
